IMPORTANT DEALER SERVICE INSTRUCTIONS AND NOTIFICATION OF RECALL

Service Bulletin: 012

Subject: Recall campaign 07V-253, Vespa GTS250 i.e. exhaust system repair

EXHAUST MANIFOLD REPLACEMENT

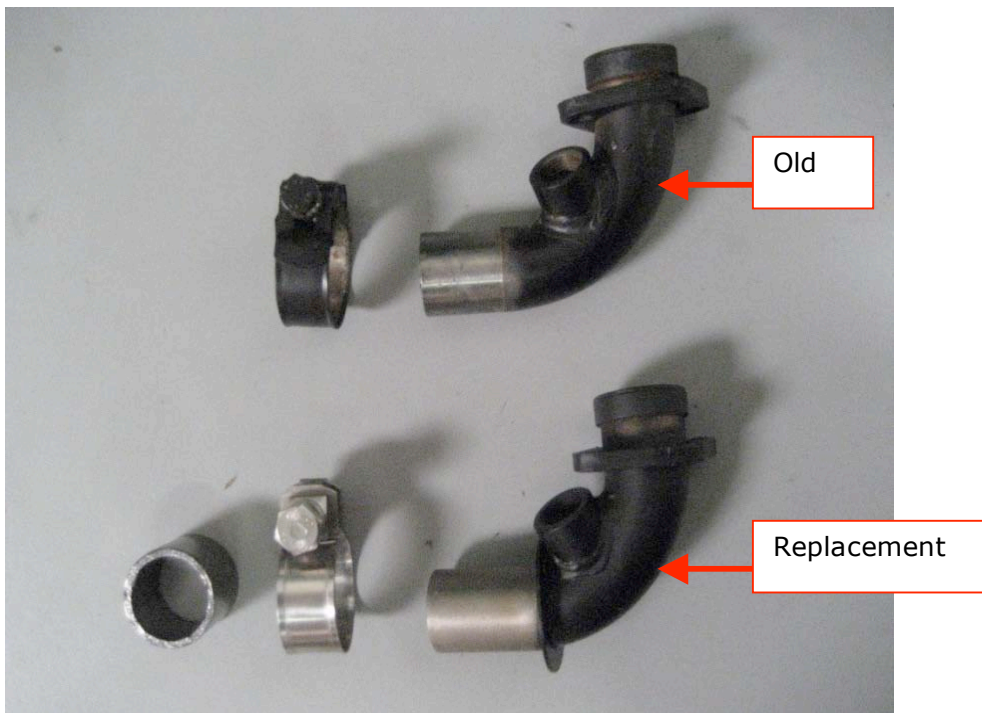
The above picture references the old exhaust flange and the replacement exhaust flange kit part number 872659.

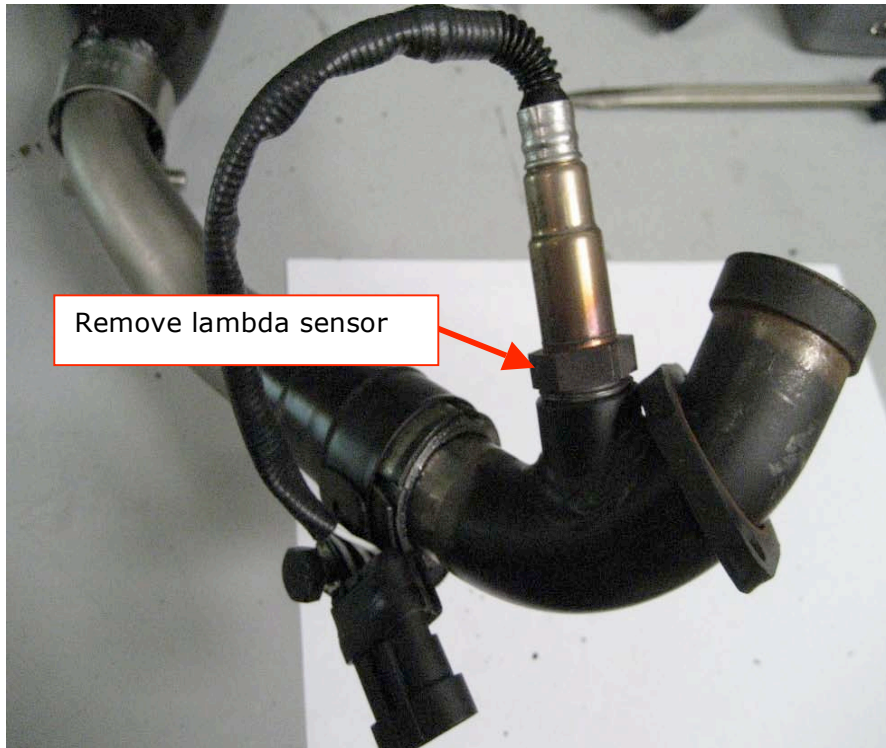
Remove lambda sensor

With the complete exhaust system removed from the vehicle remove the lambda sensors. Refer to page 88 and 89 of your Vespa GTS workshop manual for exhaust removal.

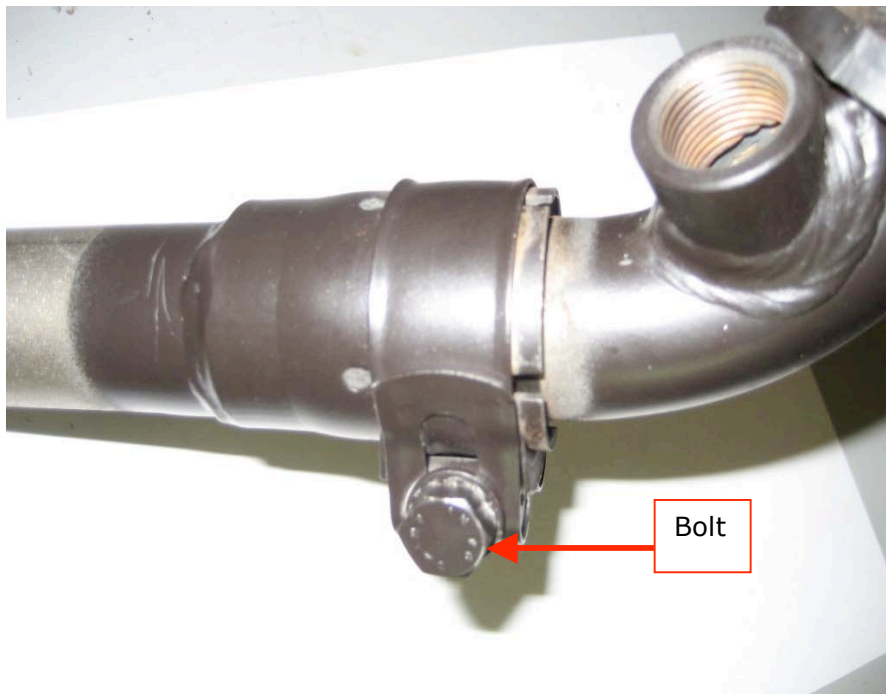
Bolt

Loosen the 13 mm bolt to loosen the clamp.

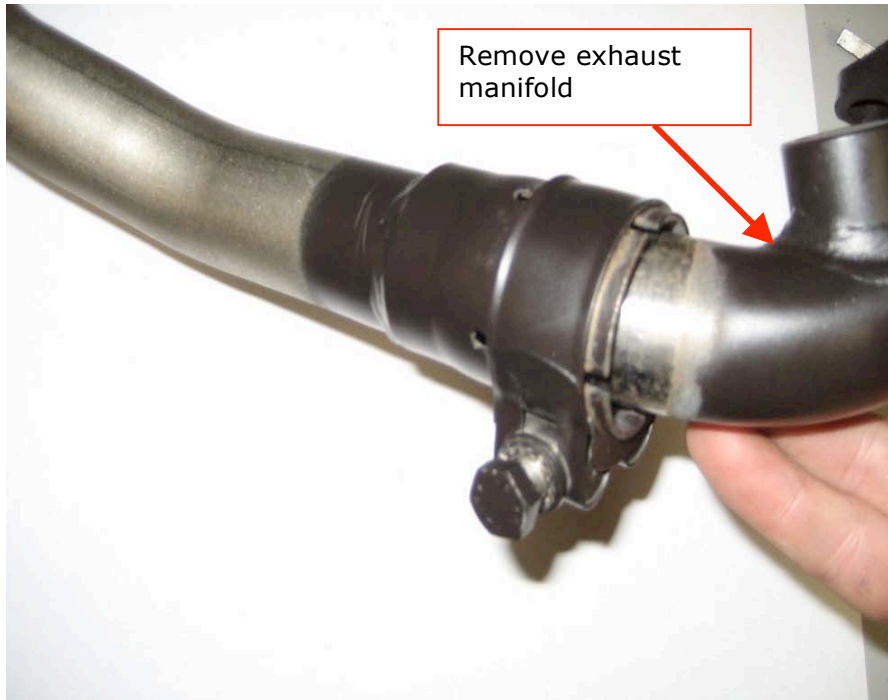
Remove the header pipe from the exhaust box.

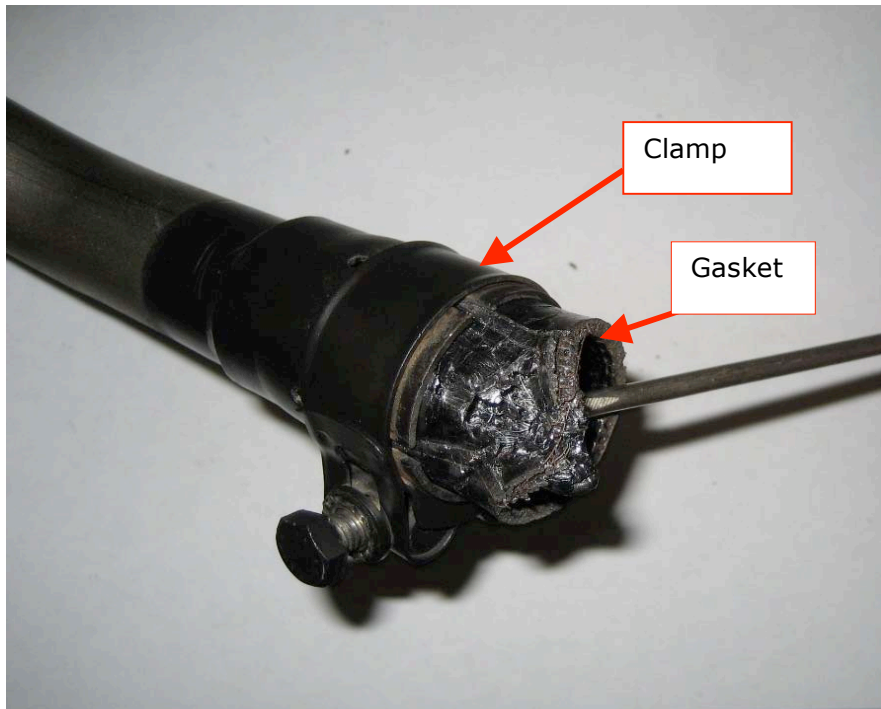
Remove the exhaust packing and clamp.

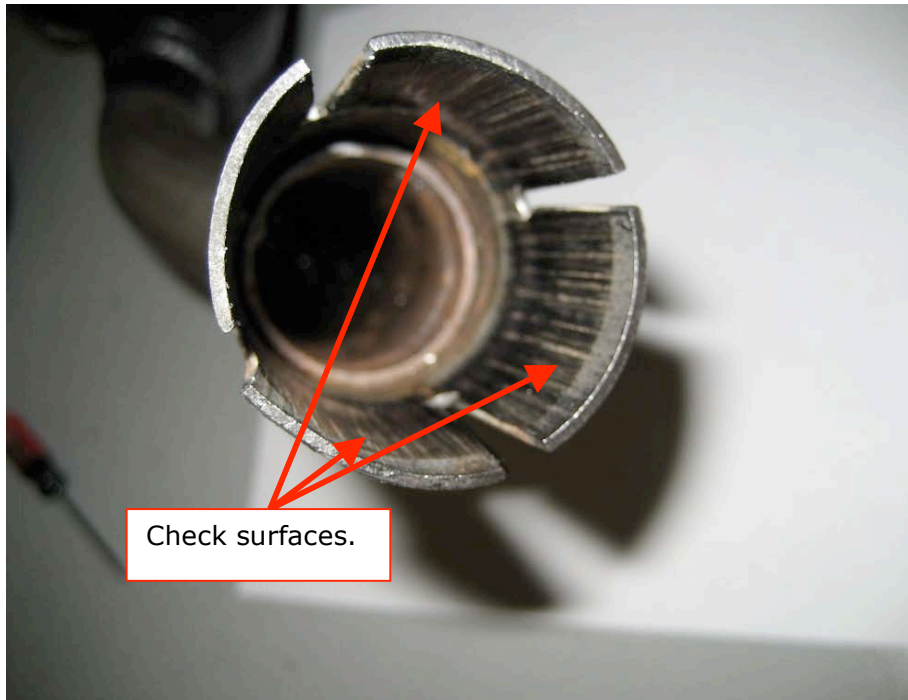
Once all packing is removed check and make sure all surfaces are clean. This will help the installation of the exhaust gasket.

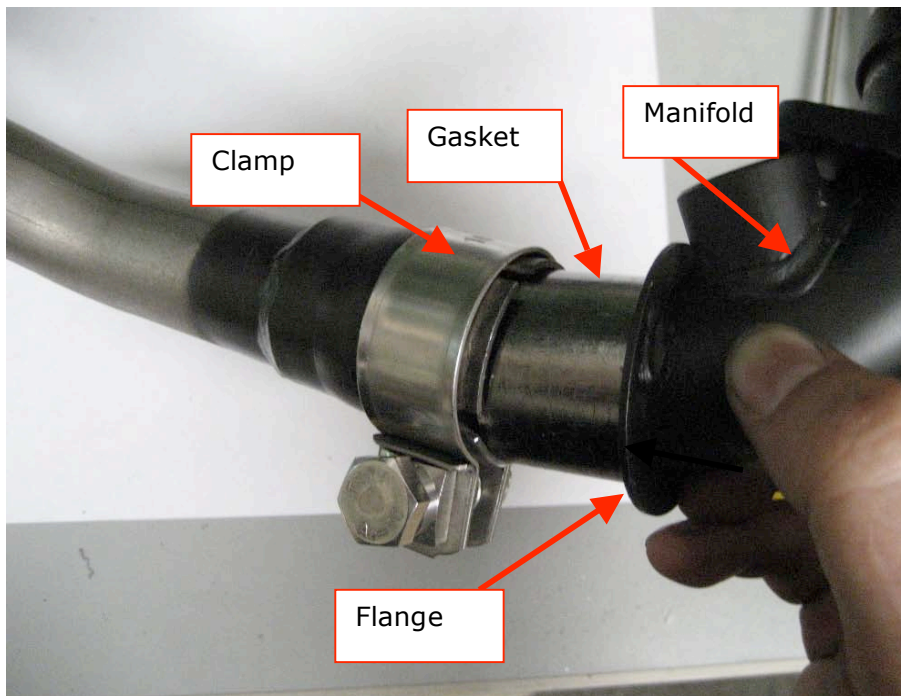
Install the new clamp supplied with the kit, but **do not** tighten down at this point. Fit the exhaust gasket onto the new manifold. Push the new exhaust gasket in with the manifold until fitted all the way down to the flange.

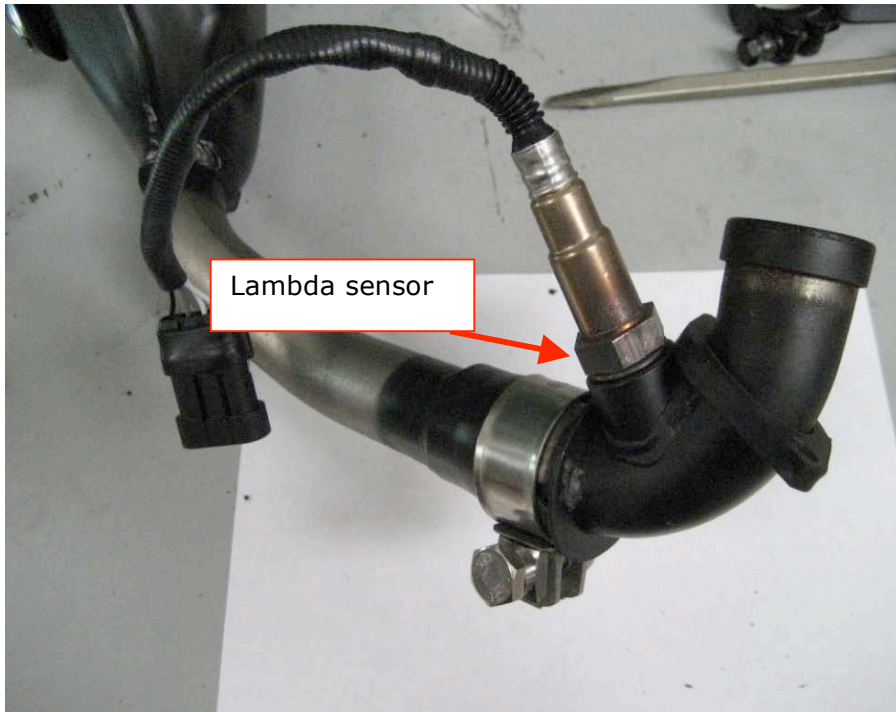
Replace the lambda sensor and tighten down to 40- 50 Nm (29.5 -36.8 ft lbs.).

Lambda probe tightening on exhaust manifold 40 ÷ 50 Nm
(29.5 -36.8 ft lbs.).

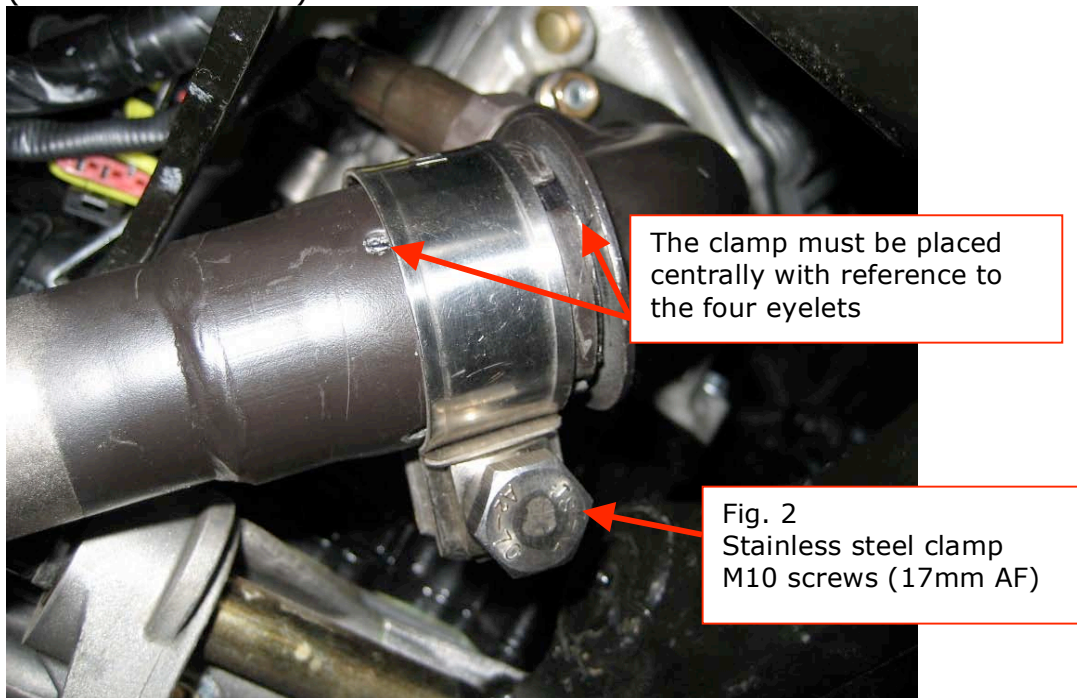
Once the exhaust system installed to specification (follow workshop manual exhaust removal in reverse as shown on page 88 and 89) and the manifold is properly lined up to the exhaust port on the cylinder head. Make sure to check that the four eyelets are visible and that the clamp is centered. Tightened down the clamp to 15.2 - 18.15 Nm (11.2 - 13.4 ft lbs.).

Exhaust manifold-muffler joint tightening (two bolts) 12 ÷ 13 Nm
(8.8 - 9.5 lbs ft.)
